Reflections: The mystery of Lake San Cristobal: A natural lake no more? By: Lyn Lampert and Camille Richard, Chair and Coordinator, respectively, of the Lake Fork Watershed Stakeholders, Lake City, CO, July, 2008.

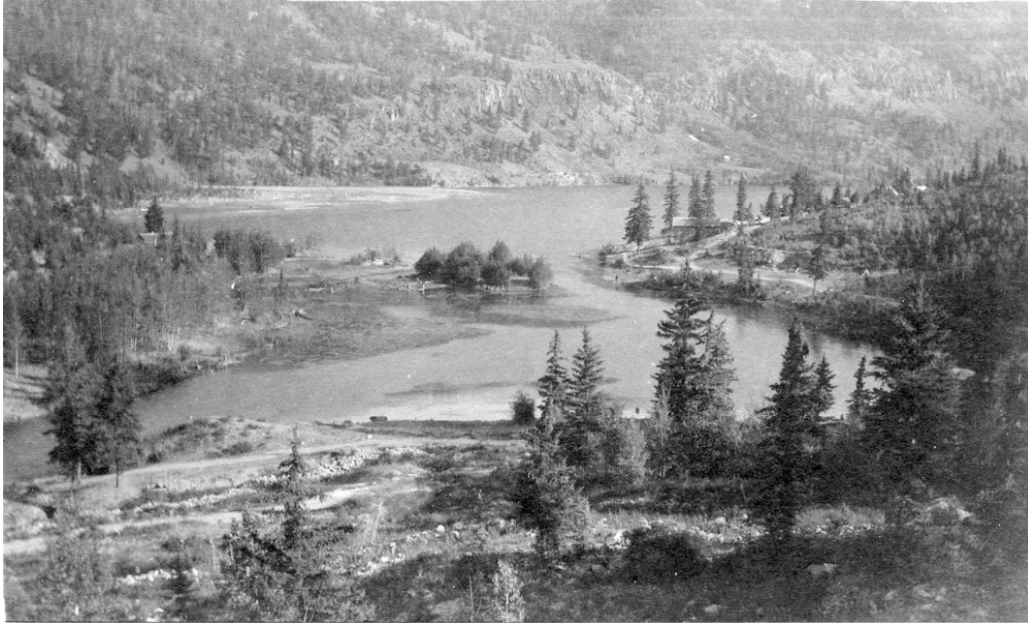
1. “natural lake level” - Black and white photo of the lake under past “natural” lake levels. The Slumgullion earth flow forms the natural dam which is under the wetland area and small forested island. This island does not exist today, except for a small rock jutting above the water level (photo credit: Silver World Newspaper Archives).

There is little mystery, however, in how this unique body of water was formed. Had it not been for the famous Slumgullion Slide, the valley of the lake would probably be traversed today by a gentle river in a shallow canyon. About 700 years ago, however, geologists surmise that a massive movement of water saturated earth and rock changed the destiny of the quiet valley forever. The earthflow, originating near the top of Mesa Seco, near Slumgullion Pass, tore a path in the forest several miles long, and came to an oozing halt when it reached the Lake Fork valley. Thus, a natural dam was created, backing up the river for approximately two miles. The slide has caused some problems for lake recreationists in recent years, mainly from silting, but the fact remains that the lake owes its existence to the yellow gumbo surrounding its outlet.

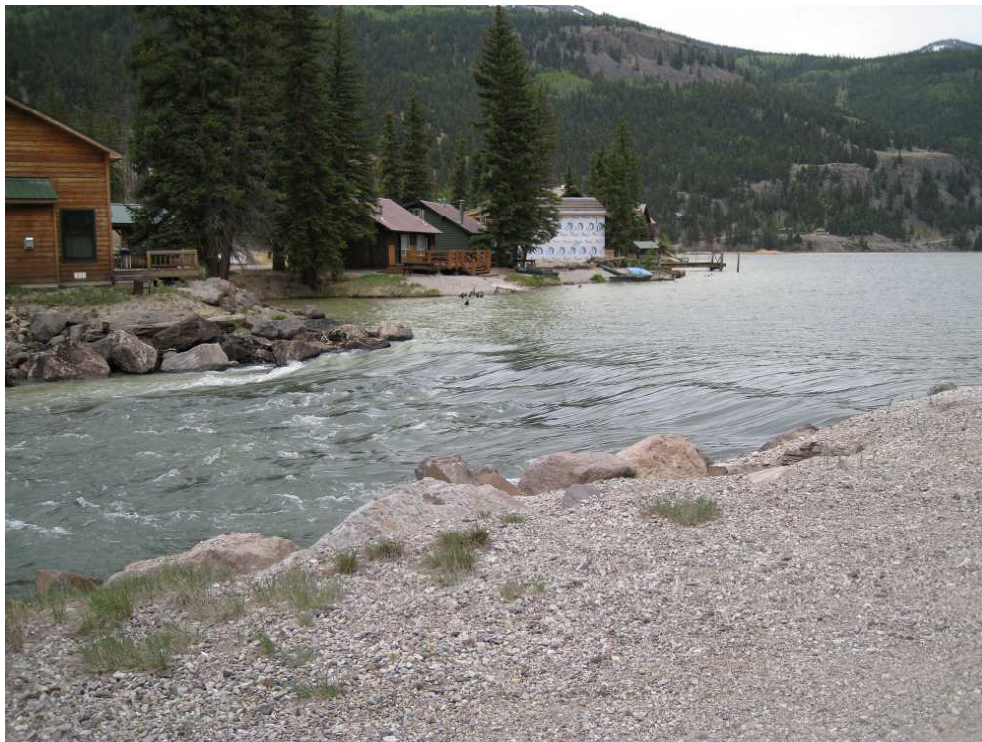
2. “outlet” – This photo shows the site of the proposed water release structure at the outlet. This is at high water level and the rocks have not been placed back in the outlet area (the rocks are piled to the side).

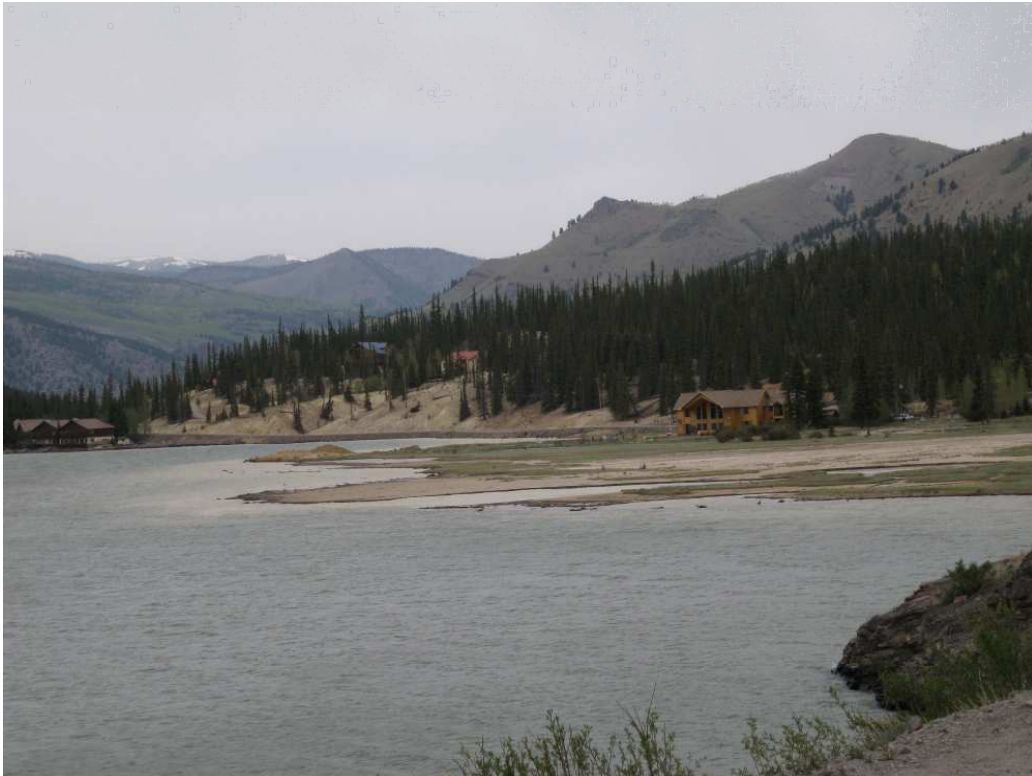
3. "siltation" – This photo shows the delta of Slumgullion creek where heavy siltation occurs and there is also heavy development pressure (on slide material!)

Ranked as Colorado's second largest natural body of water, after Grand Lake on the western border of Rocky Mountain National Park, the lake is much loved by both visitors and locals. In the 1980's, the electorate of Hinsdale County decided to place a conservation covenant on the surrounding county land so that it could remain as undeveloped and pristine as possible. However, debate is sometimes rancorous regarding size and actual "natural" lake level with some folks believing that the lake is currently losing acreage due to infilling and a lowering water level, while other old timers insist that the lake has never been higher. The debate continues to the present day, given its checkered history of outlet manipulation by miners of old and current day county officials. Throughout the past century, several structures of various design have been placed in the outlet, ranging from a wooden weir in the early 1950's (which blew out with heavy flooding) to the current practice of placing rocks in the outlet to maintain an artificially high lake level. This has been done to counter rising sedimentation at the marina near the delta of Slumgullion creek, the conduit for the arsenic laden yellow muck of the slide.

Much of this sedimentation is a recent phenomenon, as the creek had been diverted in the 1950's from its original path to the Lake Fork below, into the lake itself.

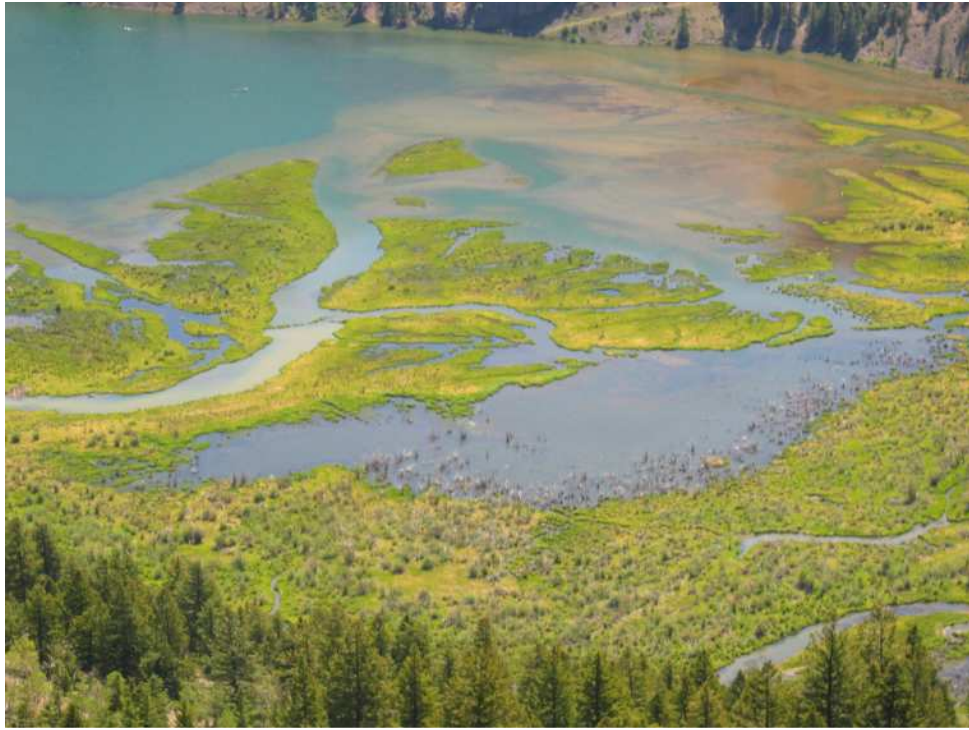
5. “inundated wetlands” – this photo shows the inlet where the Lake Fork of the Gunnison flows into the lake. Wetlands here have been flooded with loss of significant willow areas due to the county maintaining an artificial lake level. One can see where the boundary of wetlands was prior to flooding, with standing dead willow twigs still evident.

The actual lake level continues to be a mystery and a controversy. In the early 1990's, the Colorado Water Conservancy Board (CWCB) designated a "natural" lake level at 8995 ft and hold the water rights of the lake as part of their in stream flow and natural lake level program. The level was determined during recent history during which time the county has maintained an artificially high water level. As a result of this uncertainty, a new and more permanent threat to the "naturalness" of the lake looms on the horizon. A water release structure to be placed at the outlet is being proposed so that the top three feet of the lake can be reserved as augmentation water, with rights held by Hinsdale County, the Town of Lake City and the Upper Gunnison River Water Conservancy District. This would require that CWCB relinquish their rights of the top three feet of water and designate the natural level at 8992 ft. Emotions run high regarding this proposal, and the county electorate will again come to the voting booths in the fall to determine the fate of our beloved lake.

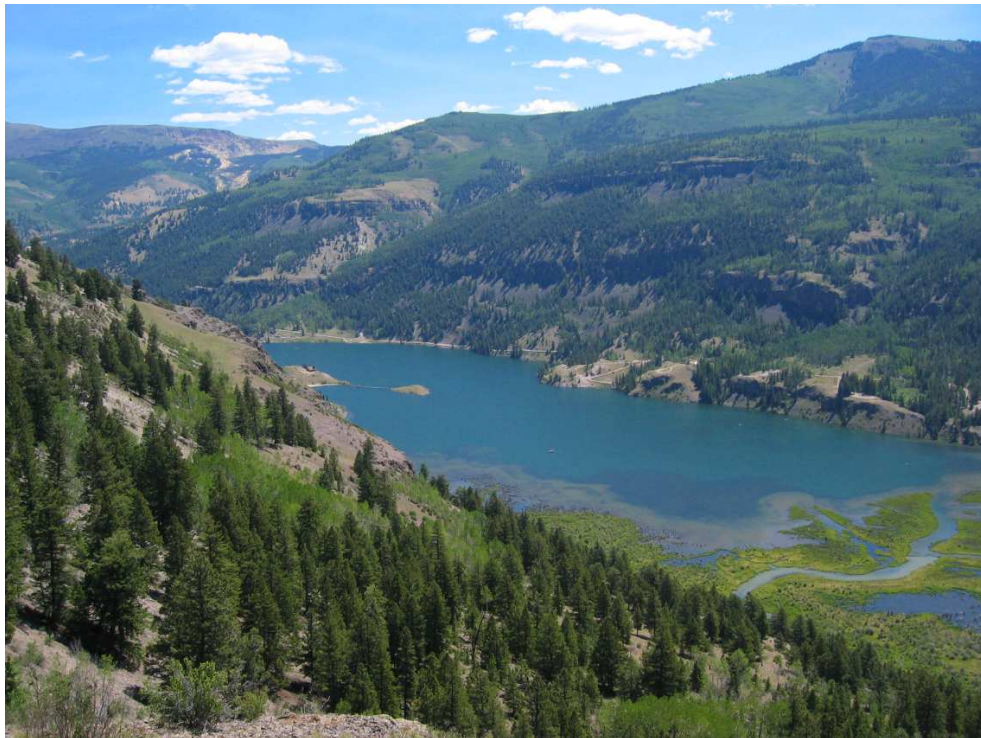
6. “Lake and Mesa Seco” – a view of the lake with the source of the slide, Mesa Seco, in the distance, upper left corner of the photo.

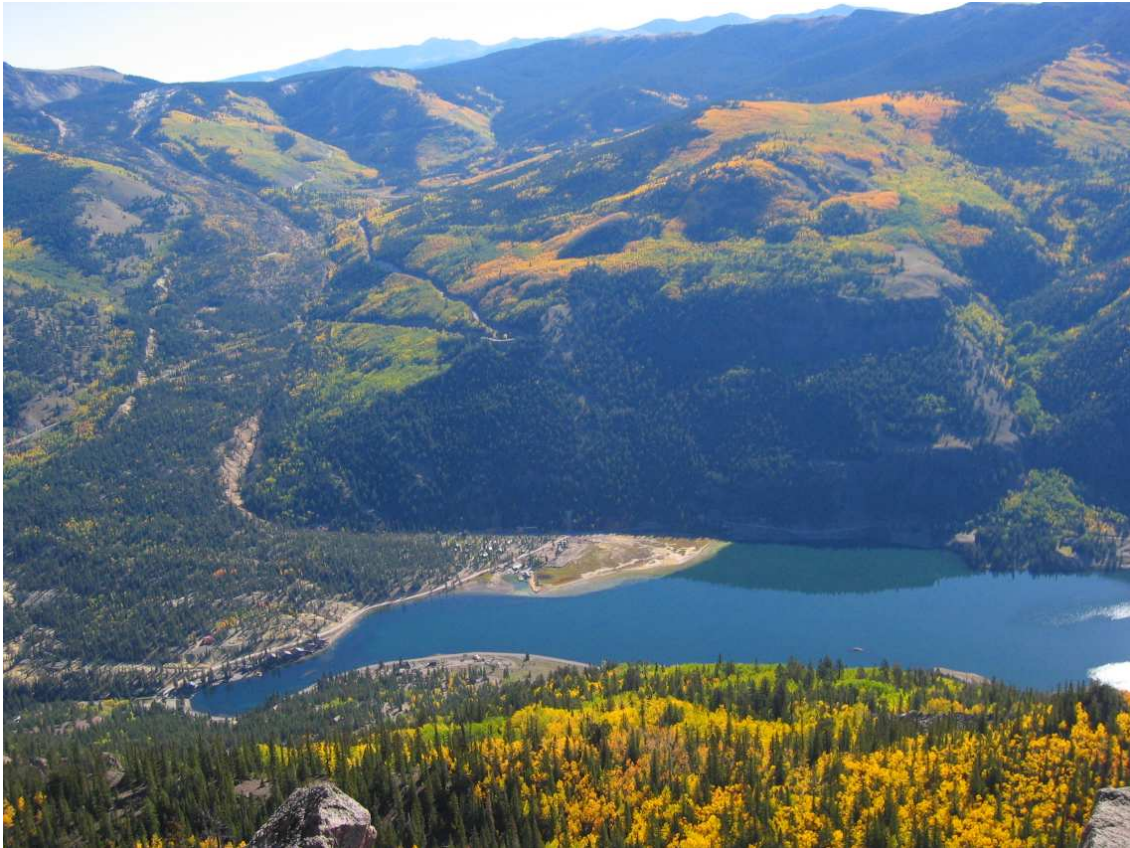
7. “slumgullion flow” – this photo shows the path of the earthflow and where it dammed the lake.
